TOWN OF ARLINGTON  
MASSACHUSETTS 02476-4908

MEMORANDUM

RE: Intersection @ Park Ave and Route 2's Frontage Roads

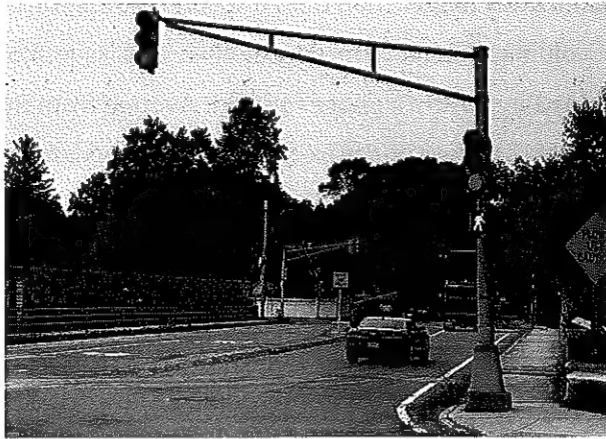
they had a green light, because of a missing visor on a Park Avenue signal, as seen in the photo to the right. Furthermore, outdated "doghouse" style left turn signals currently exist at this location. MassDOT

- Perform maintenance on this signal, to check that it is up to MassDOT standards.
- Install Flashing Yellow Arrow left turn signals to replace older style 5-section signals.
  - Program a pedestrian protect phase, so that if a pedestrian clicks the crosswalk button, left turns are converted to protected only so that pedestrians can cross in a safer manner. (See image on right)
